SIGAR 16-16 Inspection Report

Afghan Ministry of Defense Headquarters:
\$154.7 Million Building Appears Well
Built, but Has Several Construction Issues
that Should Be Assessed

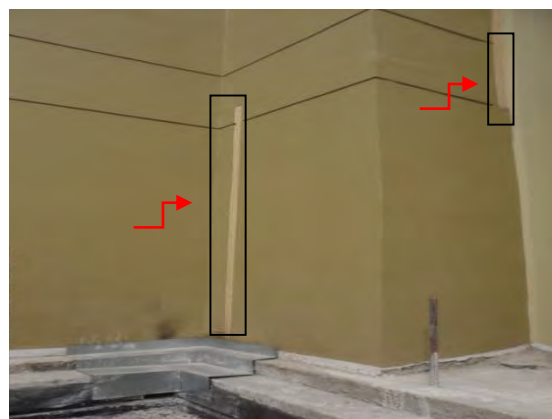
- Not all of the separation joints were aligned vertically from the foundation up to and through the roof of the building, as the contract design documents required (see photos 1 and 2 showing that the separation joints are not continuous.) As a result, the seismic calculations used are not valid. Most significantly, a structural failure of the concrete frame could result in occupants being harmed and the affected areas being rendered unusable until repairs are made. We requested Quality Assurance/Quality Control reports and photographs from AFCEC for the period of the concrete pour and form removal of specific areas. However, we did not receive the reports or photographs for the separation joints that concerned us.

Photo 1 - Separation Joint Is Not Continuous: This Joint Ends at Top of the Third Floor, and Resumes at a Different Point on the Fourth Floor

1. Assess the building's structural integrity where separation joints are not a continuous line from the bottom to the top of the building and the allowable building movement exceeds standards, and if needed, make deficient areas structurally sound.

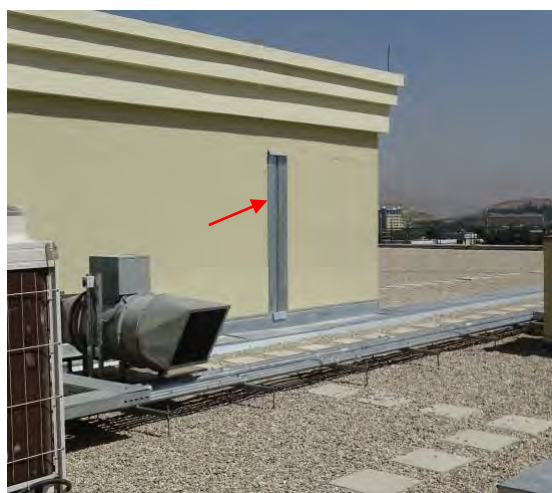
Photo 2 - Separation Joint Is Not Continuous at Top

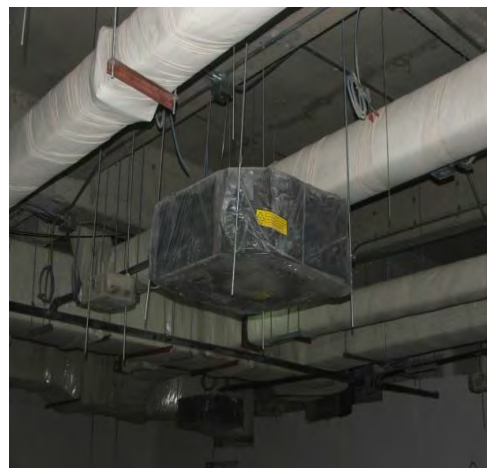
Photo 3 shows a ceiling-mounted piece of heating/cooling equipment and mechanical duct work with no lateral bracing. In addition, the fuel supply for the fire suppression pump in the basement was installed without lateral bracing, isolation joints, or containment.⁶ In a seismic event, the elevated 238-gallon diesel fuel tank could spill fuel across the pump room floor. The fuel would then leak into the rain water collection system, be directed to the wastewater treatment plant, and ultimately discharged into the Kabul River.

Photo 3 - Ceiling-Mounted Equipment and Mechanical Duct Work With No Lateral Bracing

2. Assess the need for the installation of seismic lateral bracing on non-structural components suspended from the ceiling or floor above, such as heating/cooling equipment, duct work, dropped ceilings, electrical fixtures, and drain pipes.

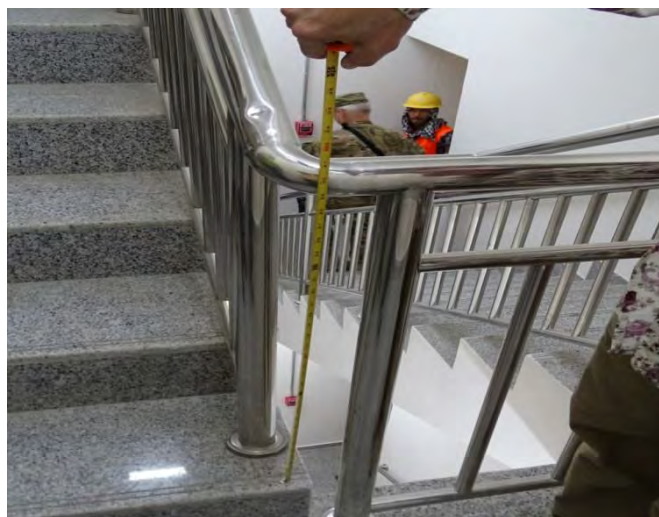
We found that the handrails on interior stairways were not installed at the proper height. During our May 27, 2015, site inspection, we measured the handrail height at 31 inches, which does not meet the minimum 34-inch height required by the International Building Code (see photo 4 showing the lower than required handrail height).¹² The 34-inch handrail height is standardized to allow the average person to reach for the handrail at an average height, so a lower height could contribute to falls on the stairways and injuries.

We also found that the handrail material was insufficient in quality. Our review of construction documents showed that the originally specified handrail material was mild steel pipe, but that AFCEC approved ITSI's request to substitute stainless steel thin-

Photo 4 - Handrail Is 31 Inches in Height and Is Dented

walled pipe.¹³ The walls of the stainless steel pipe are no more than a fourth as thick as the originally required pipe. As a result, we found that the installed handrail has multiple dents, which is common for stainless steel thin-walled pipe. The substitution to the thin-walled stainless steel pipe will result in increased maintenance costs for the handrails, which run the risk of being dented further when furniture is moved into the building.

Our draft report included a sixth recommendation for CSTC-A to address the defective handrails. In its comments, CSTC-A informed us that Gilbane Federal corrected the height of the handrails in November 2015. We confirmed during our post-earthquake inspection on January 7, 2016, that CSTC-A acted on the recommendation and corrected the handrails. Therefore, we did not repeat the sixth recommendation in our final report.
